# **Madron Church**

**Archaeology Investigation of a Flat Buried Gravestone,  
& Possible Lych Gate  
From a Water Pipeline Trench Insertion.**

**Archimedes Archaeological Consultants, Penzance**

# AAC - Madron Church Sewage Pipe Trench 2021

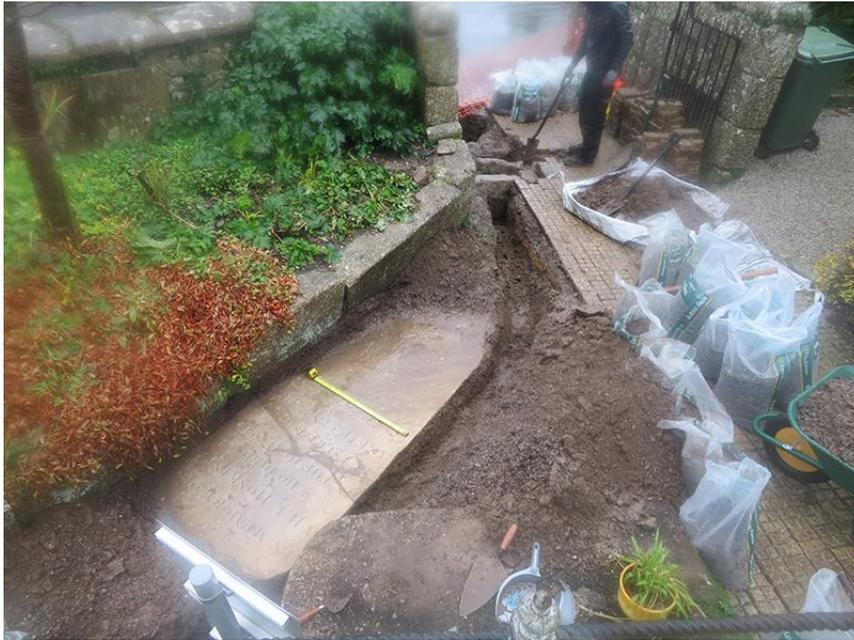
Frontispiece: Pipe Line at Entrance & Gravestone on a Rainy Day

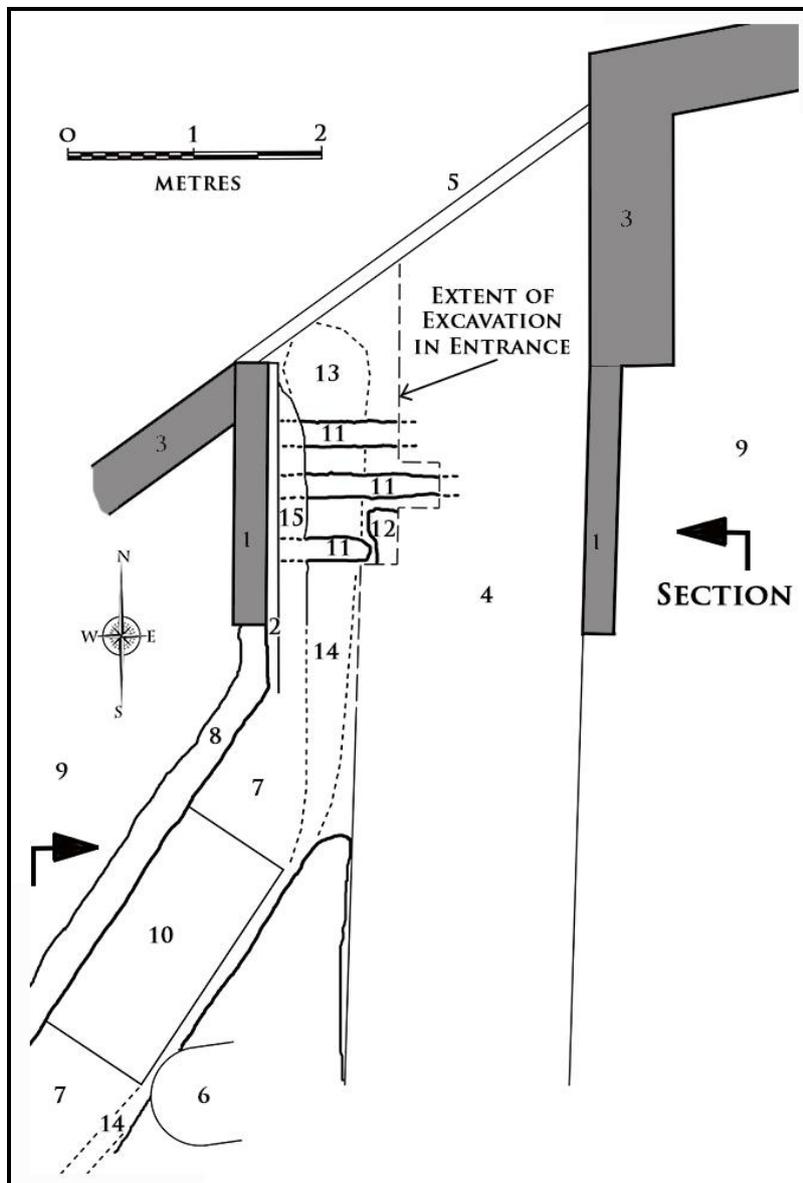
Fig. 2 Plan of Excavations at North Graveyard Entrance

With respect to Figs 2 & 3, the following numerically marked features were identified:

1. Two North Graveyard Entrance granite block walls 10" wide, making a distinctly broad entrance between them of 100-102" wide. The intended dimension was 100", the extra 2" is accounted for by wall lean outwards.

2. A flat cut regular slate flag section going under (1), and extending southwards along (8) to at least the bend in the low graveyard retaining wall (8). Probably indicating that the path (7) to the Tower was slate flagged.

3. Graveyard walls
4. c.1980's white ceramic block tiles (see foreground in Fig. 4) forming path from North Graveyard Entrance to North Porch
5. Granite kerb, flush top surface, without a step.

6. Flat laid Headstone adjacent path- (not investigated)- see Fig. 5, left side under trowels.
7. Path from North Graveyard Entrance to Tower and beyond. Currently gravel /mud.

8. Low graveyard retaining wall to (7), abuts (1) on western side. Formed of granite blocks as seen in Fig. 5 to right.
9. Graveyard
10. Sandstone Headstone of William Hoskings (Plot 83)

11. Three granite beams (16" depth x 8" wide) that support lost slate flagstones- part of (2). A mortar bed (15) for white ceramic tiles (4) sits on these beams. Beams are very degraded by erosion/damp, but appear to have been regularly shaped in one instance. See under tape in Fig. 4

12. The southern most of the three granite beams (11) is broken about 80cm out from the West side of the Entrance. A replacement section of granite masonry (12), which also fills in the area between the lost southern section and the middle granite beam- though as a flat top pad rather than beam. It indicates that the original arrangement including the three granite beams was altered for secondary reasons at some point- probably repair, but not necessarily exclusively.

13. Larger hole excavated for pipe run access chamber/man hole cover by Contractor. Interacts with new sewage access under adjacent tarmac scar in road.

14. Sewage pipe trench. Generally about 30-40 cm deep and 30cm wide. It went only superficially under the gravel/ grit of the existing path, giving little indication of the general ground matrix. No stratigraphy was identified at the minimal depths encountered. This would be accounted for by the usual grave excavation turnover debris forming the background deeper graveyard stratigraphy normally interspaced with construction debris layers.

15. The mortar bedding layer for the existing c.1980's white ceramic tile (4). Contained a large amount of charcoal and lime, not cement based suggesting it may be a reused bedding layer from the previous/earlier slate slab flags as remaining at (2).

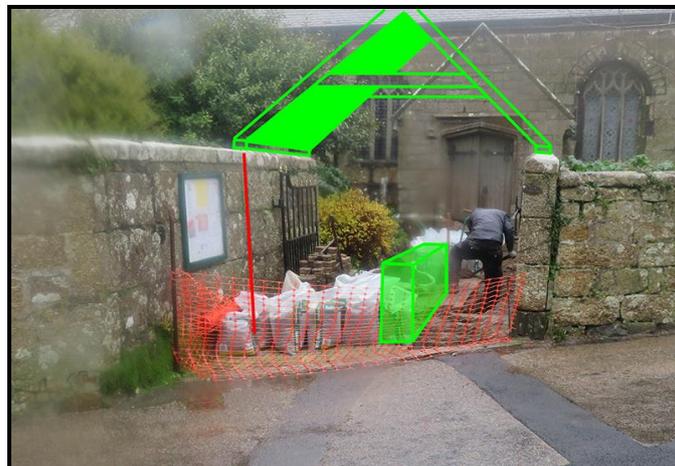
Fig. 8 North Entrance Looking South, with Reconstruction.

The final part of the picture here derives from the question: "why go to all this trouble for a mere two wall entrance?" The answer being that: "It probably wasn't just a two wall entrance." Looking at Fig. 8, the lean outwards on the West (right) side of the entrance wall is very apparent. The red line on the opposite side- marking the straight joint between the East entrance wall (1) and the Graveyard wall (3), is also noticeably leaning outwards too. Why would both be leaning outwards? The obvious answer is that they had an A frame collared roof structure on top- as shown in green in Fig. 8. It was possibly also arched braced with a gable infill at both ends. In addition, given the width, there may have been a central bench, separating the entrance into two walkway routes: "in and out". Exemplars for both the roof- as a Lych Gate and the bench are shown in Figs. 9 & 10.

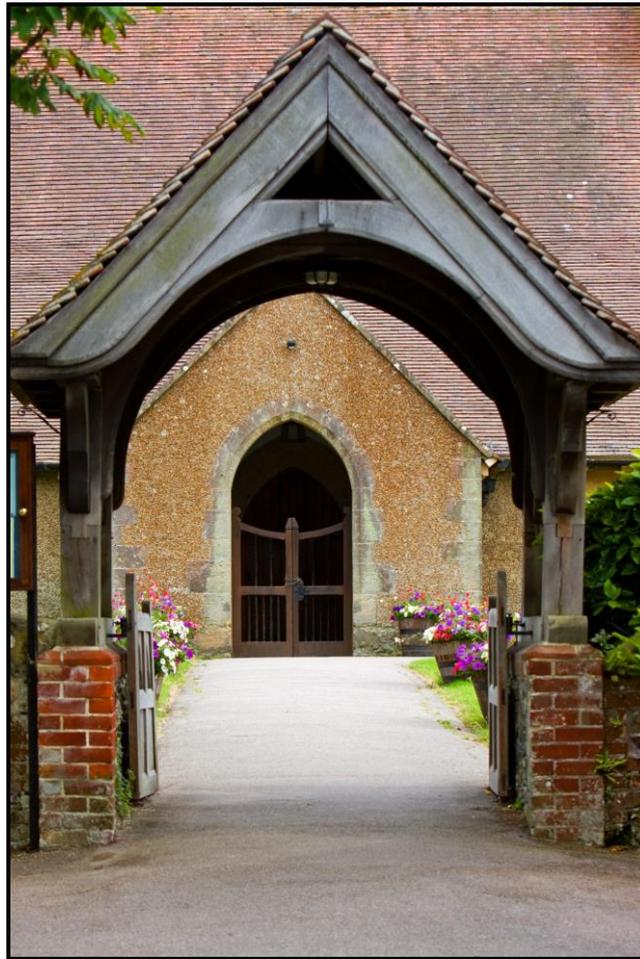
Fig. 9 Lych Gate Direct to Porch Sat on Flat Chamfered Walls  
(<https://www.publicdomainpictures.net/pictures/50000/velka/church-lych-gate-entrance.jpg>)

In Fig. 9 there are three interesting minor additional minor correlations with the entrance details at Madron. Firstly to the right side in Fig. 9, the post supporting the roof is leaning outwards, just as the walls do at Madron. Secondly, concerning the route, a comparison with Fig. 8, show the identical 'direct route' layout from church yard entrance gate to church porch. Thirdly, the interface between the roof base and wall top is the same- flush chamfered, allowing a good draining ability to prevent rot in the wood wall plate for the roof supports sat on the wall top. The entrance width proportions too, are virtually identical.

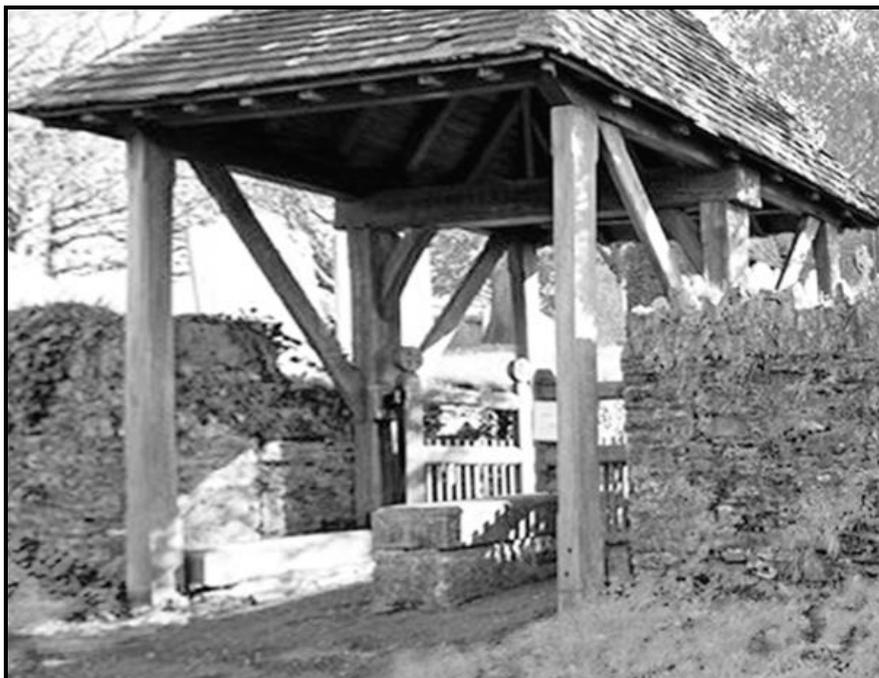
Fig. 10 Lych Gate at Rame Church With Central Bench

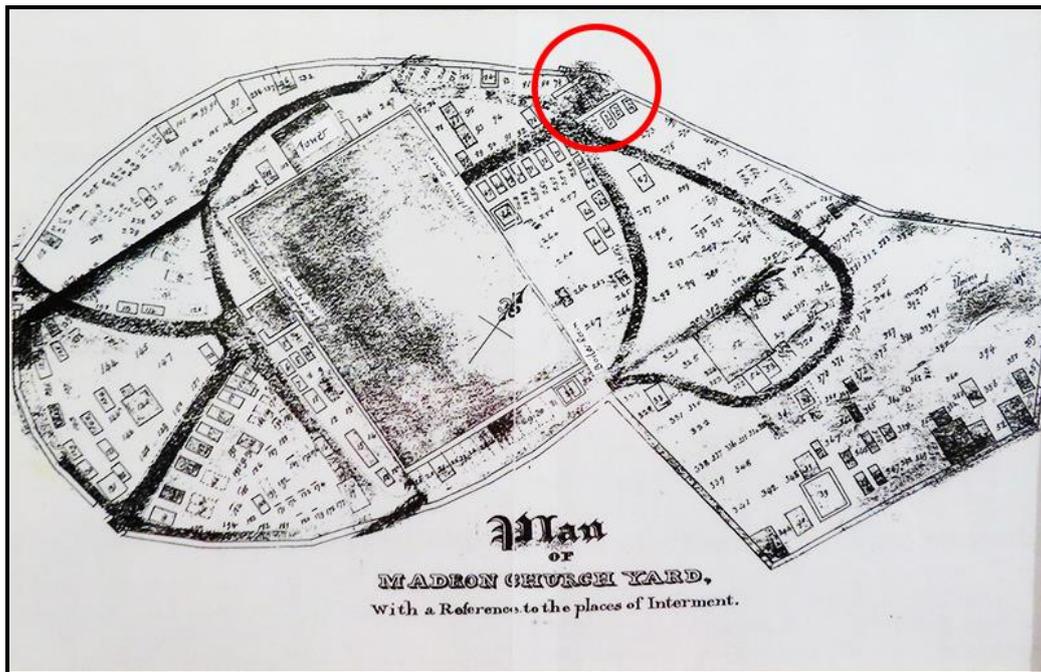
Fig. 11 Copy of Burial Plot Map in Church (dated separately 1852), North Entrance Highlighted

Referring to Fig. 11, the map is referred to in a C20 list accompanying it as shown in Fig.12.

This states that it is from 1852, and the map shows the present entrance walls within the superimposed red circle as they are today. Hence the wall base of the presumed Lych Gate was there in the mid C19.

The final piece of evidence was the map itself, which shown in Fig. 11, is shown in detail in Fig. 18 below.

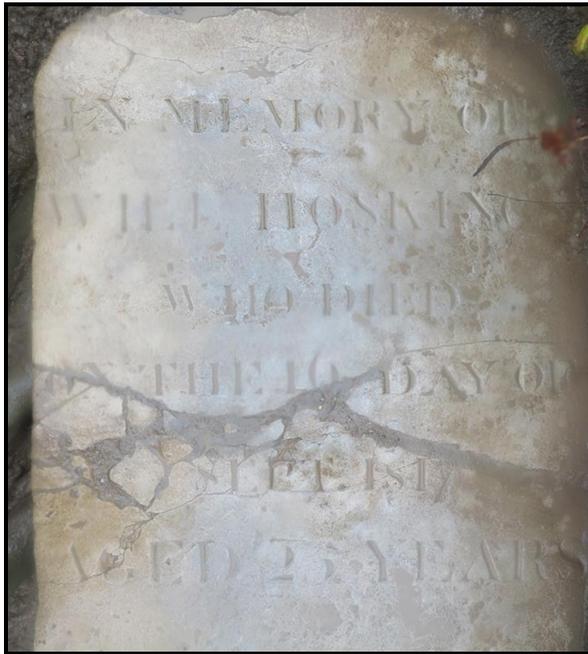
Fig 13 Plot 83 Headstone as Existing

Excavation of the partially revealed inscription rapidly resolved these points- and fully revealed is shown in Fig. 13. The inscription when fully revealed, as shown more clearly enhanced in Fig. 14 reads:

IN MEMORY OF  
WILL HOSKINGS  
WHO DIED  
ON THE 16 DAY OF  
SEPT. 1817  
AGED 25 YEARS

Plot 83 with William Hoskings in, was trodden under foot by every person walking to the West Door. However in terms of level, the 3' wide x 80" long x 4" thick grave stone cover- (not a headstone) has a top surface about 10cm/4" below the slate slab defined path surface only a metre or so away, and the path is relatively level hereabouts. This suggests that the path surface- whether mud or gravel was intended to cover the grave top and inscription. There is wear on the grave cover- as the worn and mostly obscured 2mm strokes of the inscription show, but that still seems relatively light for an otherwise highly exposed and almost 200 year path component.

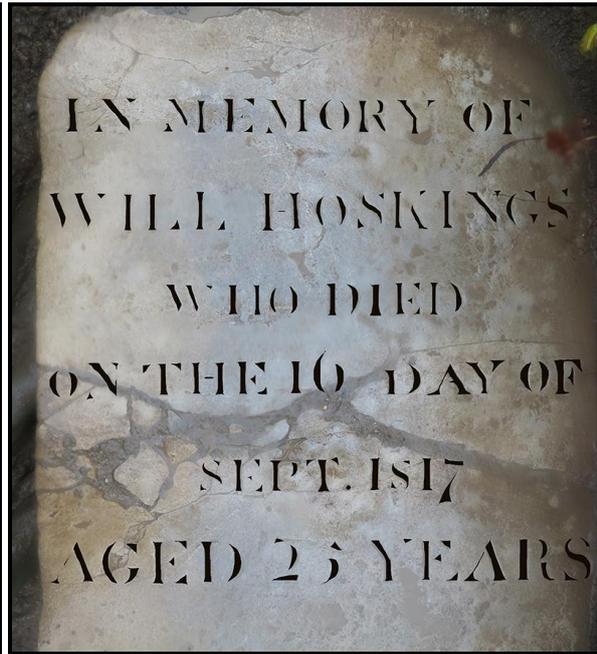
Fig. 14 Headstone Inscription Enhanced

Of note is the style of the inscription- a very minimalist use of carving strokes. Almost all those seen are from about 5mm deep cuts. However in one or two instances- the 'A' in 'YEARS', the front stroke of the A can be clearly seen- from a cut only 2 mm deep. In most other cases, the surface wear has obliterated these shallow strokes. The horizontal bar in the 'H' of Hoskings in Fig. 14 is only just discernable. The style is close to a similarly dated example from within the Church- see Fig. 15. and even more so in terms of inscription style and sandstone material to an undated headstone in the church floor of 'Harriet Frances Vyner' shown in Fig. 16, but probably later from the 1820-30's.

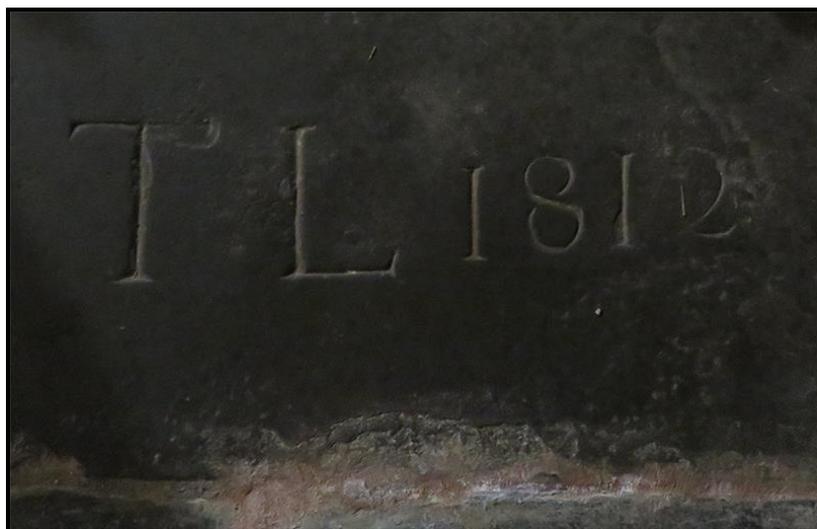
Fig. 15 Slate Inscription in Church Floor "TL 1812"

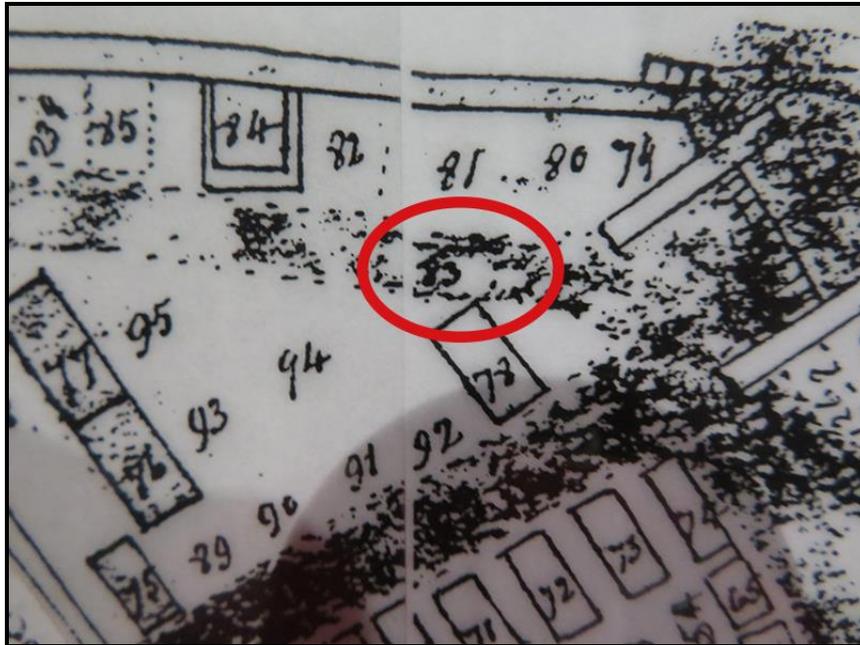
Fig. 18 Detail of 1852 Burial Plot Map by North Graveyard Entrance. Plot 83 Highlighted

The map detail shows plot 83 highlighted, which referring back to the archaeological excavation plan in Fig. 2, and the photo in Fig.5, is exactly in the same place as Will Hoskings gravestone as excavated. The oddity of its placement in the path is also resolved. Plots 80/81 containing the two other William Hoskings, according to the Burial Plot list are immediately adjacent and to the West, above the path. Plots 82 and 79 don't appear to be Hoskings, according to the Plot List, hence the path headstone plot 83 William was probably a son, who dying young at 25 appears to be the last Hoskings to die and be buried in this odd location- or at least before 1852, when the map was made. The burial plot map shows only this one instance of a path burial in the church yard indicating its unusualness, but the logic of proximity to previously buried and same named and immediate family being self evident.
